## Newt Survey 15<sup>th</sup> and 16<sup>th</sup> April 2016-04-16

### Survey

### Report on the site

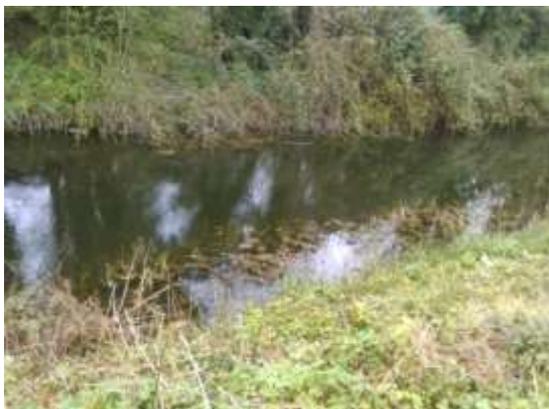
The Eastern cutting. The sculpting of the bank has been naturally colonised by pond vegetation. This provides egg laying material for female newts. This is very pleasing to see.

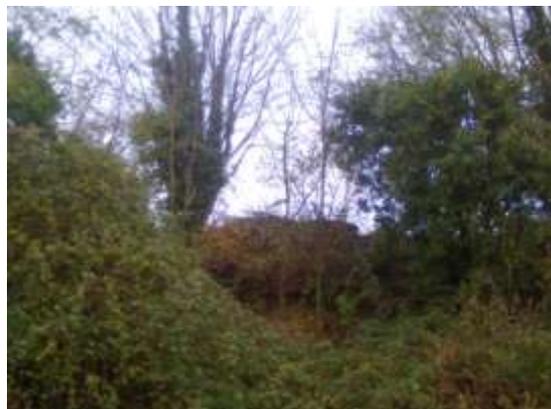
There is substantial amount of garden waste being tipped down the banks of this pond.

There is substantial garden waste on the banks of the Eastern cutting. If this continues unchecked it will avalanche into the Eastern Cutting and pollute the pond.

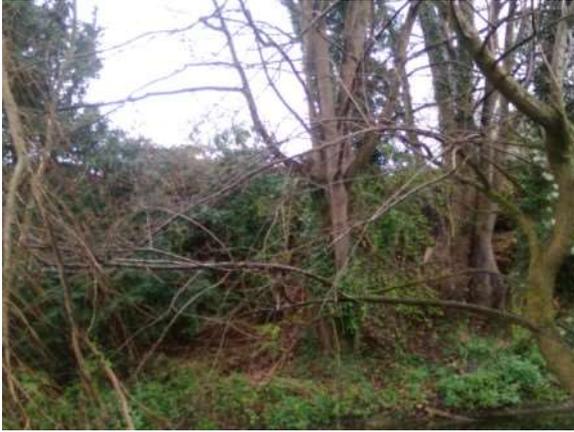
Garden waste by the Eastern cutting.

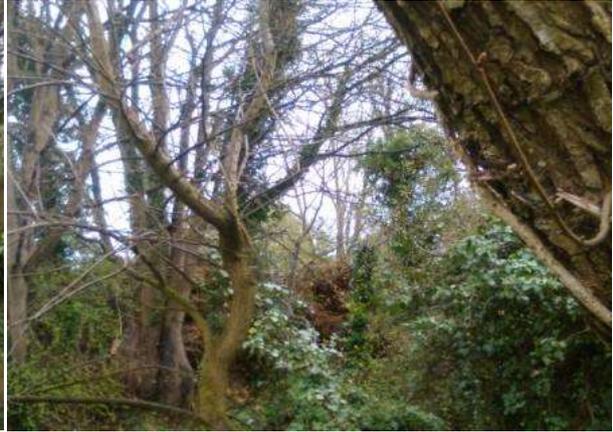
Garden waste by the Eastern Cutting

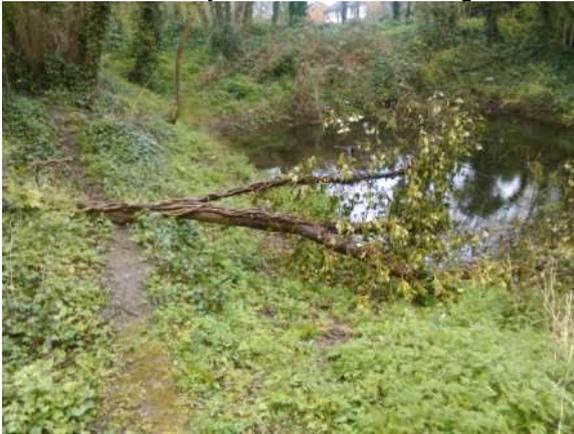
There is a tree down on the Eastern cutting which prevented us from surveying this end of the pond.

There is a tree down at the end of this pond and this prevented us from surveying this end of the pond.

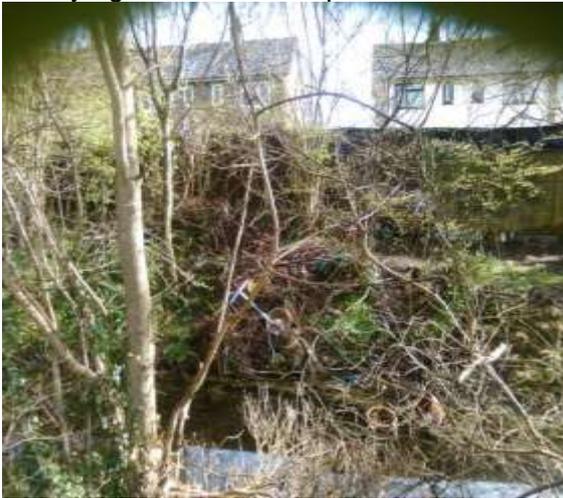
An electric fan, amongst other things.

There is a great deal of fly tipping further up in these cuttings at the back of the houses in Midland Road. This needs to be cleared and disposed of, ideally by people with newt licences because you will undoubtedly come across Great crested newts under the rubbish.

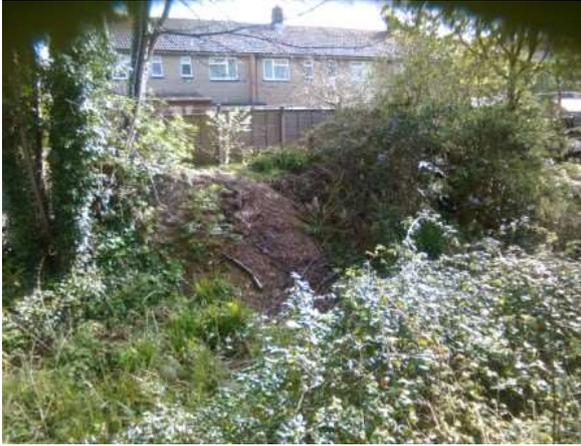
A large amount of soil.

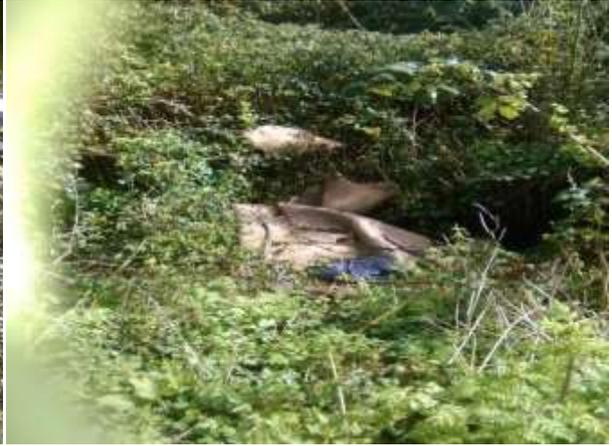
Carpet/underlay

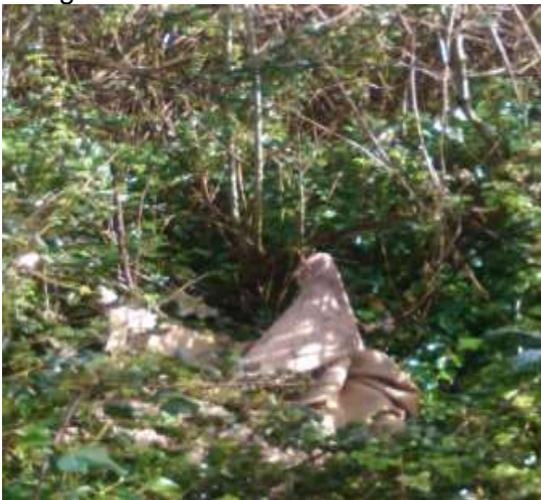
Carpet/Underlay

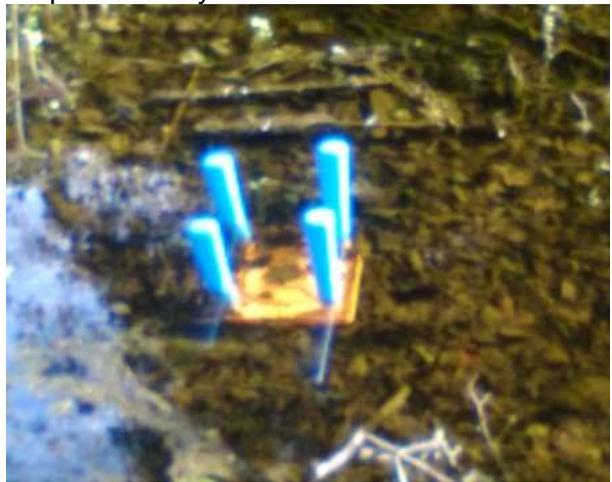
Child's table

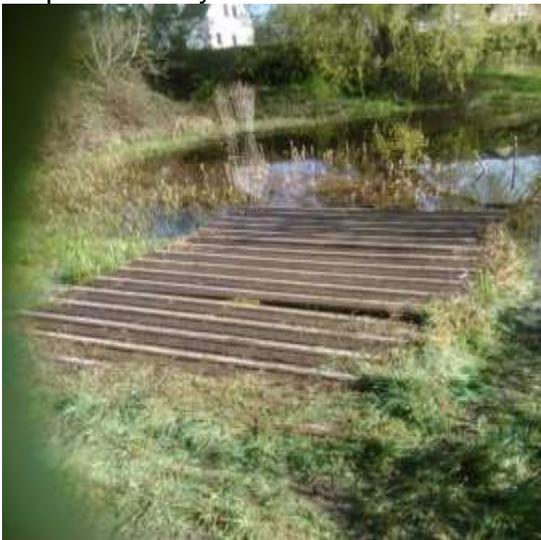
Dipping platform, probably at the end of its life.

The dipping platform is probably coming to the end of its life and needs to be replaced. We had to warn the people who came on the survey not to stand on it for fear of damaging it further, and damaging themselves (falling in). Some of the planks lifted up as people stood on it.

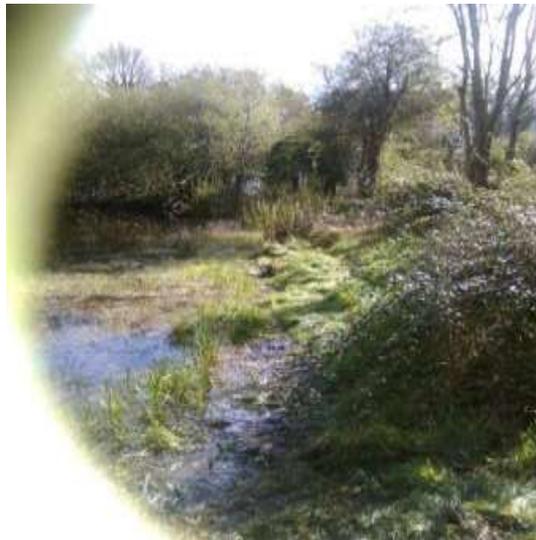
Trees and bramble beginning to encroach on the main pond.

Trees and bramble are beginning to encroach the main pond and will need to be removed, to ensure that the pond can be surveyed and accessed.
